Did a loose cable connection cause Dali blackouts?

Nearly six months after the late-March Dali bridge allision disaster outside the Port of Baltimore a just released report from the National Transportation Safety Board (NTSB) Office of Marine Safety presents some newly found insights.

September 15, 2024

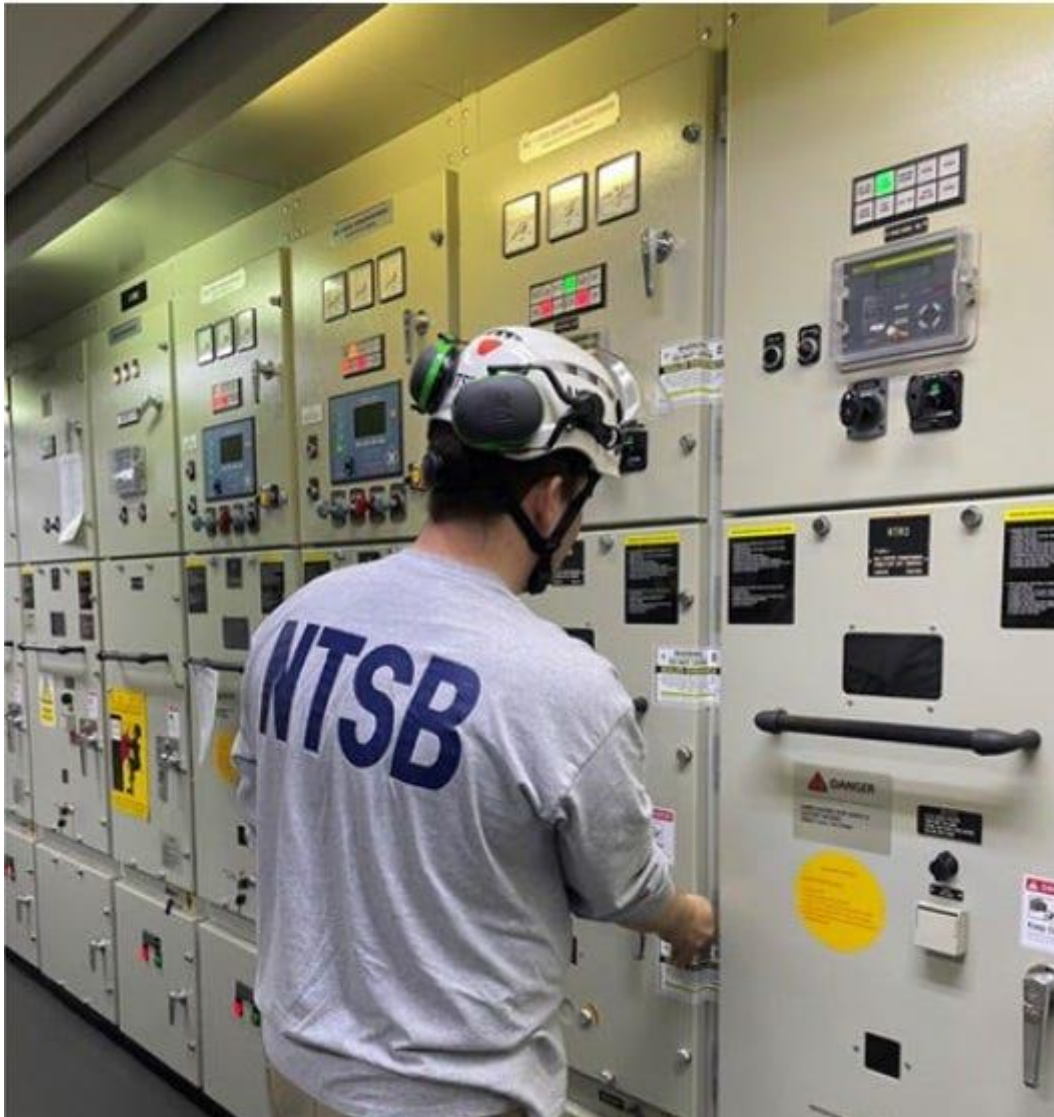
HHI engineers found that one of the cable cores that connects the DB1X-1 relay of the GPT1 panel to the control line was loose. The DB1X-1 relay is for bus blackout detection. Two ends of the DB1X-1 relay are nodes 381 and 382. Node 381 is connected to node 304 of the control line and node 382 is connected to node 305 of the control line...**HHI engineers found that the cable was loosely connected at node 381. That condition can create an open circuit and interrupt the 110VDC power**

to the HR1 UVT Coil, which would trigger an under voltage release trip of HR1. This would result in a 440V blackout without leaving any records in the HiMAP-T sensor....

HHI engineers advised that if the cable is loosely connected, the UVT control voltage might not maintain a steady value of 110VDC. If this condition is not met, the HR1 will open, which would lead to a Low Voltage (440V) Switchboard blackout. If the transformers are set to an automatic switch mode, LR2/HR2 is automatically closed and TR2 is connected when HR1/LR1 is open.
