CMA CGM Boxship Hit Beacon Due to Lack of Crew Understanding and Procedures

Published Feb 12, 2025 6:18 PM by [The Maritime Executive](#)

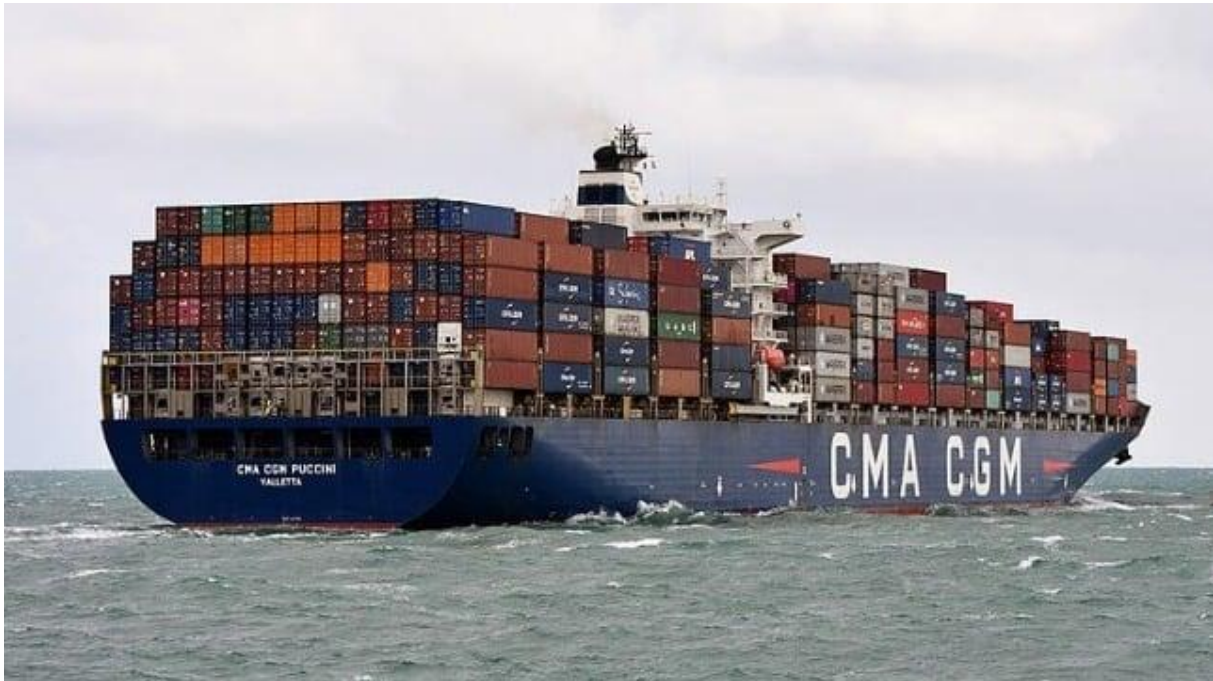
CMA CGM Puccini hit the beacon because its steering gear was incorrectly set and the crew lacked information (Bahnfrend - CC BY-SA 4.0)

Investigators pieced together the cause of the erratic steering, determining that it was due to a hydraulic bypass valve being left open by the crew after an AMSA port state control inspection the day before the incident. This resulted in the steering system hydraulics being incorrectly configured for normal operation.

It was established that with the hydraulic bypass valve being left open, the steering operated sufficiently well with minimal load on the rudder to pass pre-departure visual inspection. However, when the hydrodynamic loads on the rudder increased, with increasing ship's speed and rudder

movements, the open bypass valve allowed leakage of hydraulic oil and system pressure around the pump leading to erratic response of the rudder.

CMA CGM has taken measures to address the ambiguity by revising the steering guidance across its fleet. The liner's fleetwide "steering gear failure" procedure has been amended and titled to become the "emergency steering procedure."

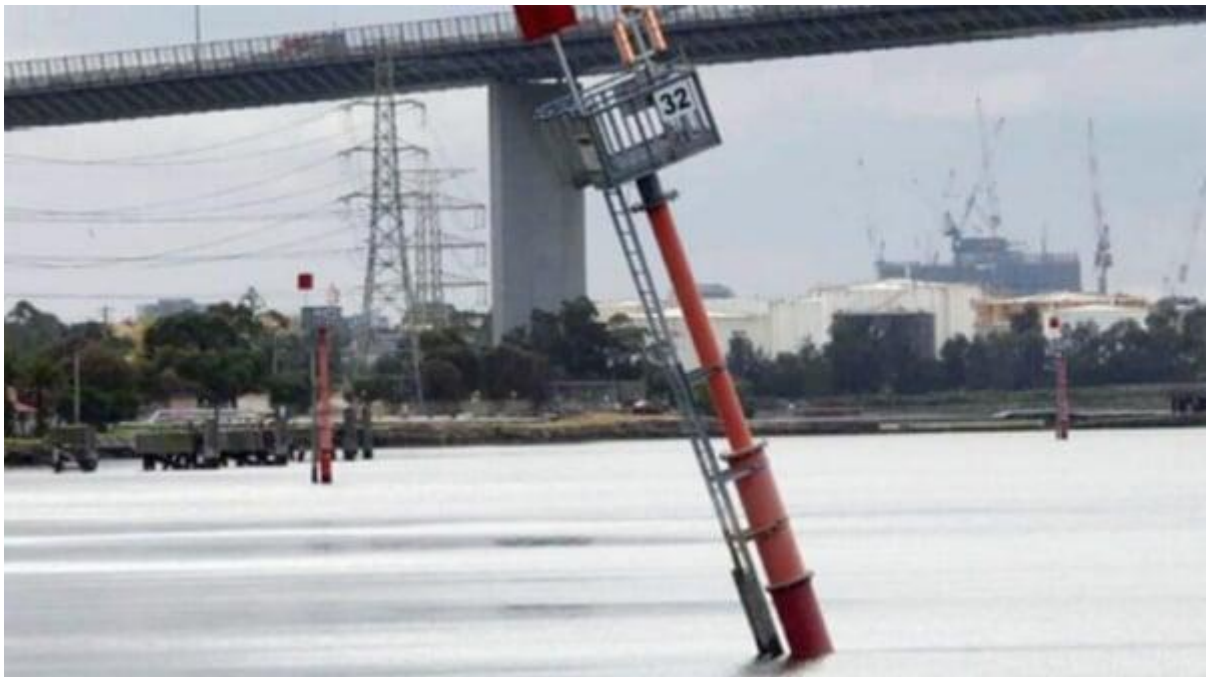
CMA CGM Puccini severely damaged the beacon while departing Melbourne, Australia (ATSB)

By 0436, the ship was moving along the channel in Yarra River after both tugs had been dismissed and a few minutes later passed under the Westgate bridge at a speed of 6.6 knots when the helmsman reported that the rudder was not responding to the wheel. With its speed increasing, the ship moved further off course and tracked toward the western edge of the dredged navigable Yarra River channel striking navigation beacon 32. At the time, the ship’s speed was 7.7 knots.

The two tugs were nearby and returned, and helped control the ship's erratic movement. The ship was then moved to Webb Dock for inspection. The ship sustained minor paint damage but the beacon was significantly damaged.

Ports Victoria has also updated the harbor master's directions for Melbourne to enhance towage requirements while transiting the Yarra River. This now includes advice for the crews of ships that experience a main engine or steering failure while transiting port waters.
